California Division of Mines and Geology

Fault Evaluation Report FER-15

September 16, 1976

1. Name of fault: Tule Creek and three related, unnamed faults
(see figure 1).
2. Location of faults: Topatopa Mountains, Lion Canyon, Wheeler Springs,
and Old Man Mountain 7.5' quadrangles, Ventura and Santa Barbara Counties,
California.

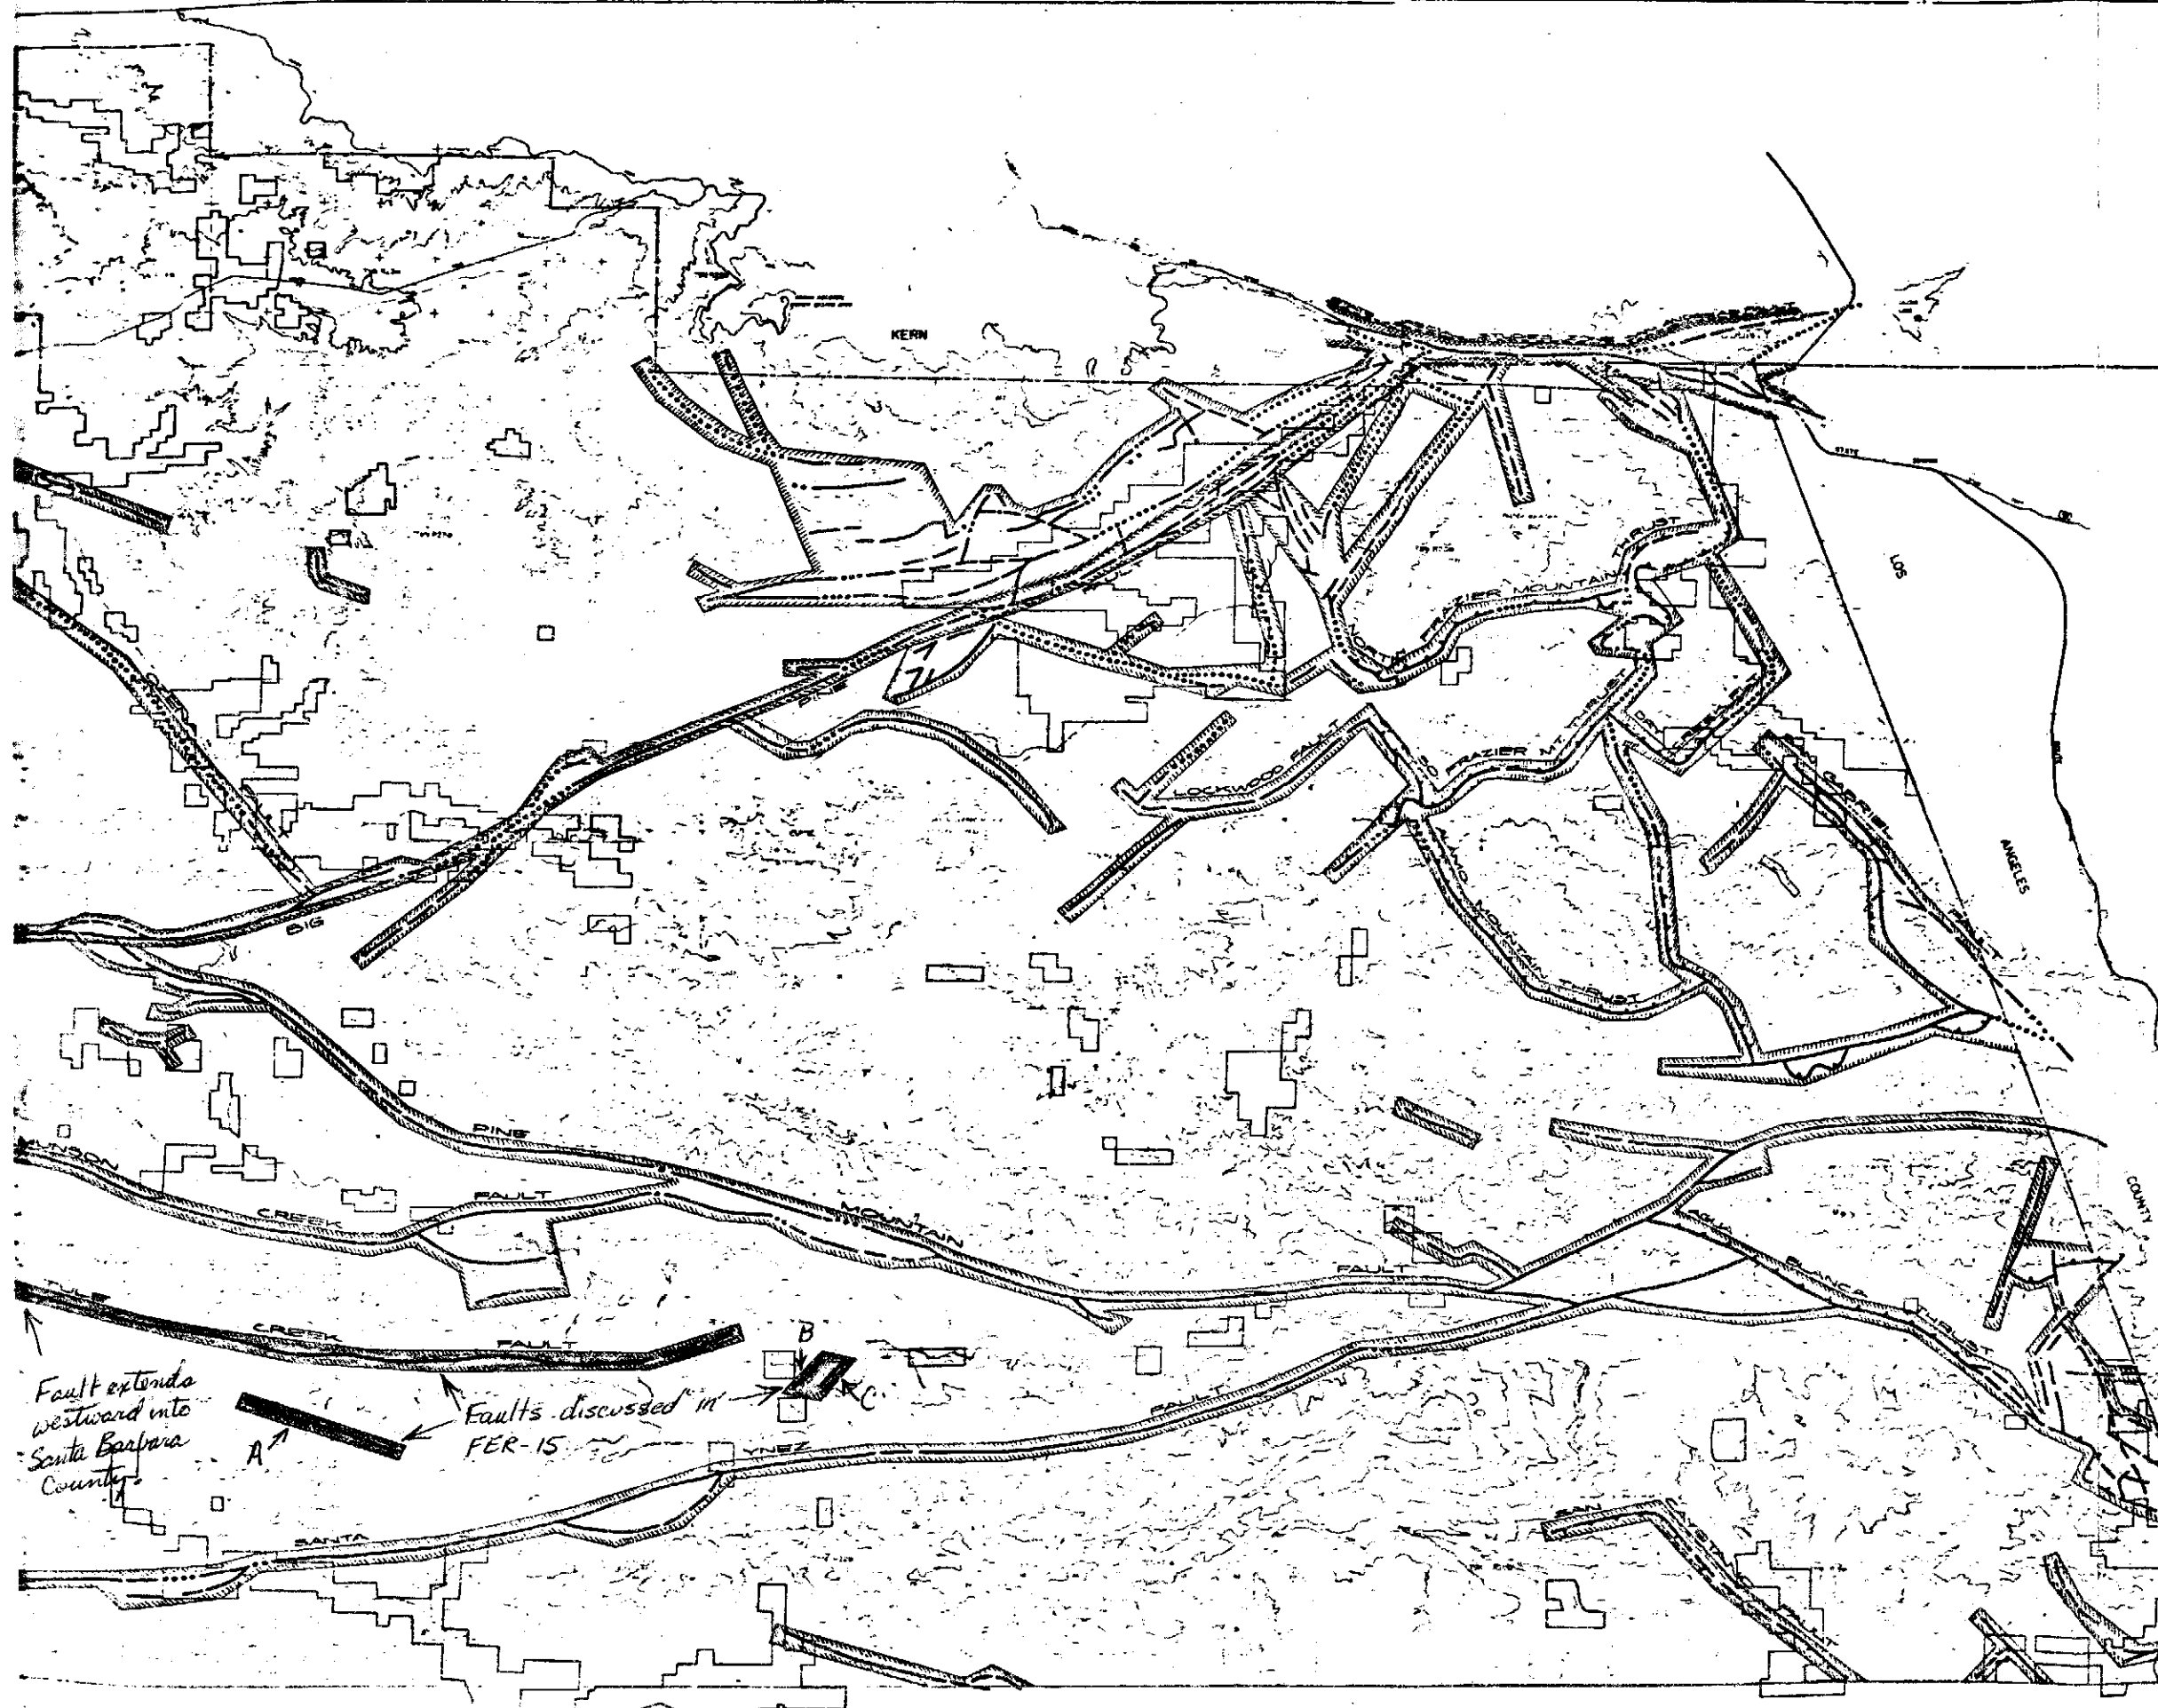
Figure 1 (From Nichols, 1974)

The youngest unit cut ^{by} the western-most unnamed fault ("A" in figure 1) is Cozy Dell Formation (Eocene). This fault is overlain only by landslide deposits; no other units younger than Cozy Dell occur along the fault (Dibblee and Fisher, 1946b). The youngest unit cut by faults "B" and "C" (figure 1) is Coldwater Formation (Eocene). These faults are overlain only by "Recent" alluvium at the south end of each mapped trace (Dibblee, 1949).

U.S. Department of Agriculture aerial photographs AXI-7K numbers 81 through 84 and 127 through 128, scale 1:2000, flown in 1953, were viewed stereo-optically. No features common to recently active faulting were observed. The strike of the bedding closely parallels the fault, as mapped, in the area examined. I was unable to distinguish the fault features from those features created by differential erosion of the surrounding bedrock. Faults "A", "B", and "C" (see figure 1) could not be identified.

8. Conclusions: The age of faulting along the Tule Creek fault is post-Coldwater Formation (Eocene) and pre-Holocene, since late ~~late~~ Pleistocene deposits are not cut by the fault. Fault "A" (see figure 1) is post-Cozy Dell Formation (Eocene) (no minimum age can be assigned). Faults "B" and "C" are both post-Coldwater Formation (Eocene) are older than the youngest alluvium. Hence, faults "A", "B", and "C" could possibly have been active during the Holocene, however, they do not exhibit any features ^{only} common to recently active faults. Those fault related features ^{along any of the faults discussed} present, are not diagnostic with respect to recency of

Fault extends westward into Santa Barbara County

Faults discussed in FER-15

9. Recommendations: Under the present project guidelines, zoning of the Tule Creek fault and the three unnamed faults specified (see figure 1) is not recommended.
